NATIONAL PROGRAM FOR INSPECTION OF NON-FEDERAL DAMS  
RESERVOIR NUMBER ONE (U) CORPS OF ENGINEERS WALTHAM  
MA NEW ENGLAND DIV APR 79

REPORT DOCUMENTATION PAGE		READ INSTRUCTIONS BEFORE COMPLETING FORM
1. REPORT NUMBER MA 00337	2. GOVT ACCESSION NO.	3. RECIPIENT'S CATALOG NUMBER
4. TITLE (and Subtitle) Reservoir Number One  NATIONAL PROGRAM FOR INSPECTION OF NON-FEDERAL DAMS		5. TYPE OF REPORT & PERIOD COVERED INSPECTION REPORT

20. ABSTRACT (Continue on reverse side if necessary and identify by block number) Total length of the dam is about 800 ft. with a height of about 22 ft. The Although there were some minor deficiencies noted the dam is considered to be in good condition. It is intermediate in size with a hazard potential of high.

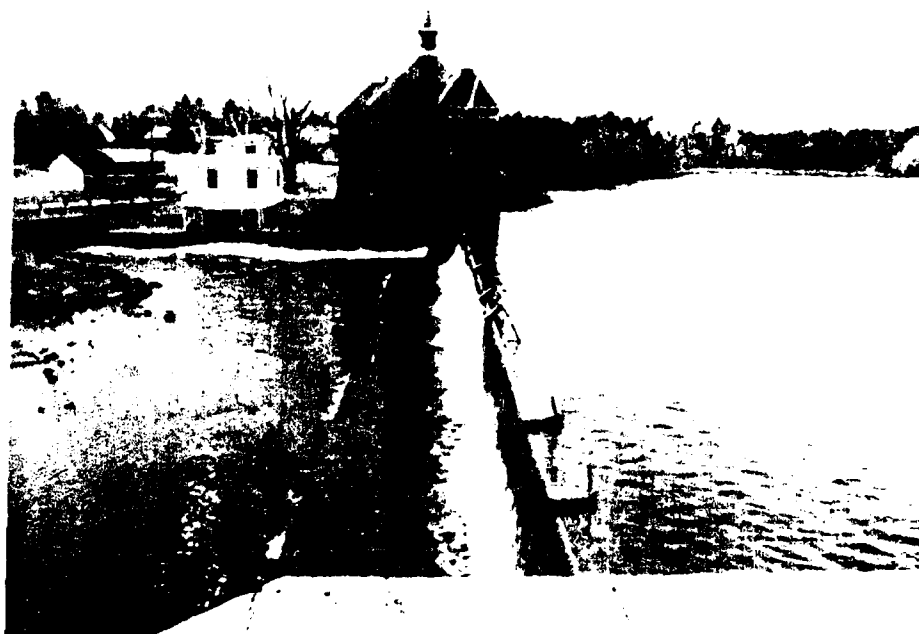
Water over the spillway weir and apron prevented a clear view of the joints. However, the weir and apron show no signs of movement or distress. There were approximately 15 rods observed along the crest of the weir, which may once have supported flashboards. No flashboards were observed on 29 March 1979. On 9 of these rods were attached wooden devices called ducks which are used to reduce the noise of the water flowing over the crest. These conditions are shown in Photos No. 2 and 9. The left and right spillway training walls, Photos No. 5 and 8, exhibit only minor loss of joint mortar.

9. Spillway weir and apron

professional engineer to observe the dam at a time when there is low or no flow over the spillway to 1) assess the condition of the granite masonry spillway weir and downstream apron and 2) the outlet chambers. If indications of seepage are observed, the Owner should then implement corrective measures.

2. Repoint granite masonry on the downstream face of the spillway weir and other walls where necessary.
3. Repair and maintain the gate house to protect the contained equipment, ensure safety of personnel, ensure that equipment is operative and minimize storm leakage into the structure. As a minimum, electric service should be restored to the structure, floor planks placed over open chambers and windows, roof flashing repaired or replaced, and gates examined.

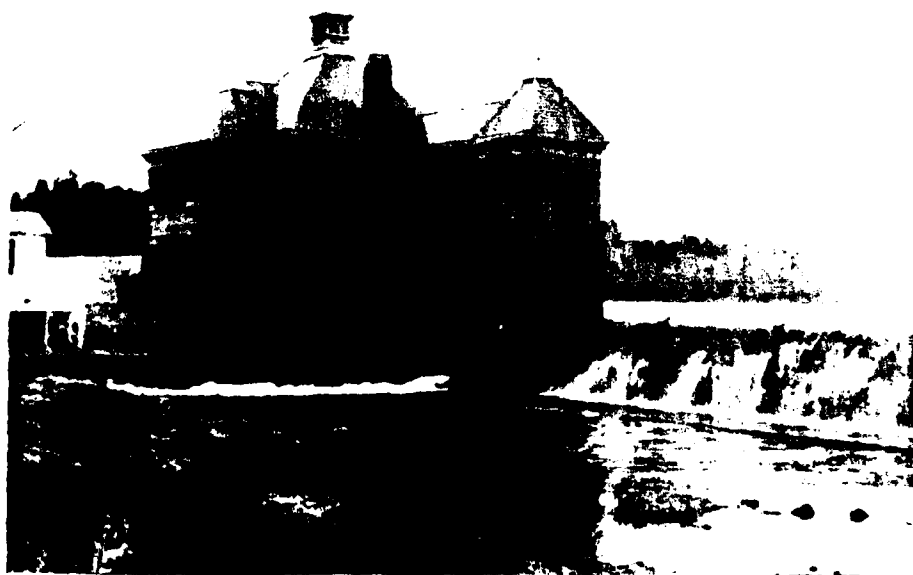
The gate house is a granite masonry structure with a slate-covered roof and is generally in good condition. The joints at and just above waste ports 1, 2 and 3 show signs of staining and efflorescence, Photo No. 10. The windows are in poor condition and some of the panes are broken. Some of the copper flashing along the edge of the roof has broken off. The exterior of the gate house is shown in Photos No. 1, 2, 4, 7, 8, 9 and 10.

10. Gate house and waste gate outlet ports
